## Field Investigation of Aggregate Blow-off of Spray Polyurethane Foam Roofs

By  
Roger V. Morrison, PE, RRC  
Deer Ridge Consulting, Inc.

Presented at the RICOWI Fall Symposium, November 11, 2010, Rock Hill, SC

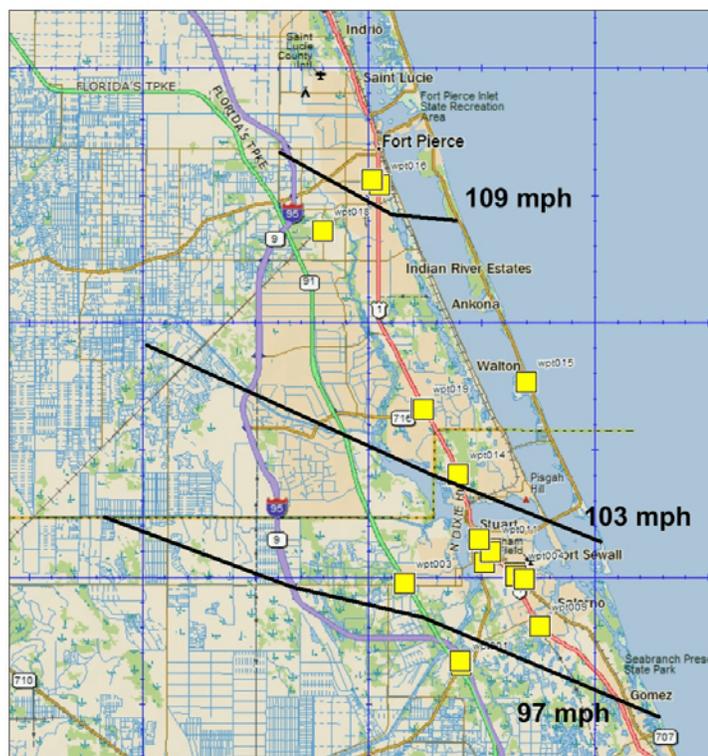
**Figure 3:** Study area with Hurricane Jeanne wind contours. Yellow squares represent inspected roofs. Wind speeds are 3-second gusts, 33 ft above ground, Exposure C. (Map from Topo North America 9.0; 2010 © DeLorme, Yarmouth, ME. Used with permission.)

Obtaining an accurate analysis of hurricane wind speeds is not a simple task. Hurricane Jeanne was chosen as the more critical storm event (Jeanne was a Category 3 storm, whereas Francis was a Category 2 storm). For this study, wind speeds were estimated using a combination of available Hurricane Jeanne surface wind speed maps and adjusting those speeds to basic wind speeds of three-second gusts at 33 feet above ground, Exposure C. The net result is the wind contour map/study area map in Figure 2.

Wind speeds were estimated based on the Figure 2 map for each building location. The aggregate samples were sieved (to determine average diameter) and measured for specific gravity.

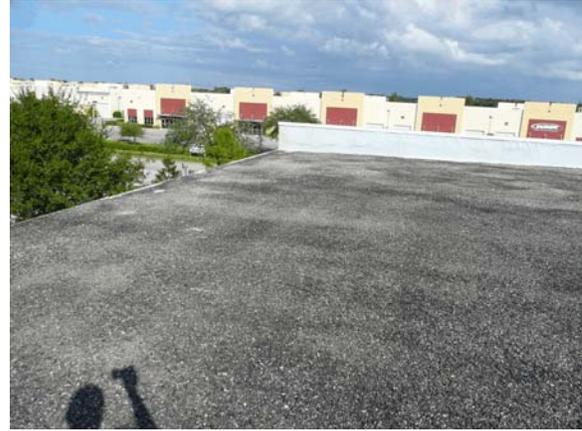
**Figure 4:** Discontinuous parapet on Roof No. 2.

For example, Roof No. 2 (Figure 3) drained at the back of the building. The parapet height varied from 10" in front to 36" (due to roof slope) at the rear where the parapet stopped at the draining edge. Aggregate scour originated at the junction of the draining edge and the 36" parapet; an effective parapet height of 36" was used in the calculations for this roof.

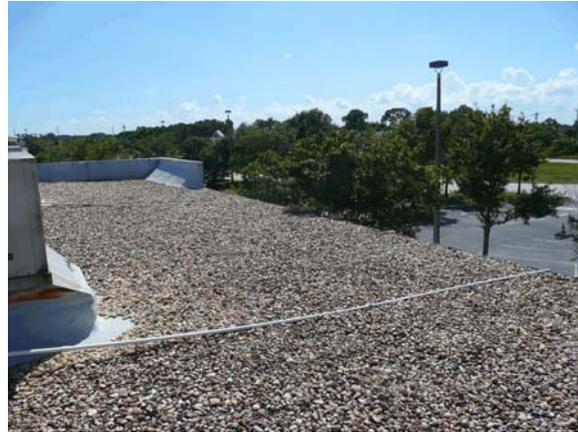
**Figure 5:** Roof No. 19 with 1.5-inch aggregate and a wrap-around parapet.

- Roof No. 8 (X-value: +39) had a 42-inch parapet wrapping the entire roof structure, providing ample protection to the aggregate.
- Roof No. 19 (X-value: +88) had been a ballasted single-ply; when this had been converted to an aggregate-covered SPF roof, the ballast stone was re-used. This roof had the greatest aggregate diameter of the study roofs (1.5" average). Additionally, while this roof had a draining edge, the 38-inch high parapet wrapped around and protected the corner (see Figure 4).

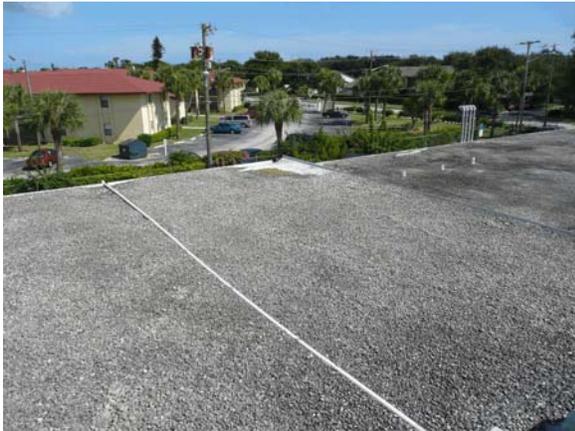
Roofs experiencing some degree of scour ranged in X-values from -23 to +37. Scour patterns were not unexpected. Exposed corners exhibited the classic “heart-shaped” or “V” pattern; corners with partial or discontinuous parapets exhibited a “tear drop” pattern.

**Figure 6:** Typical minor scour (Roof No. 16).

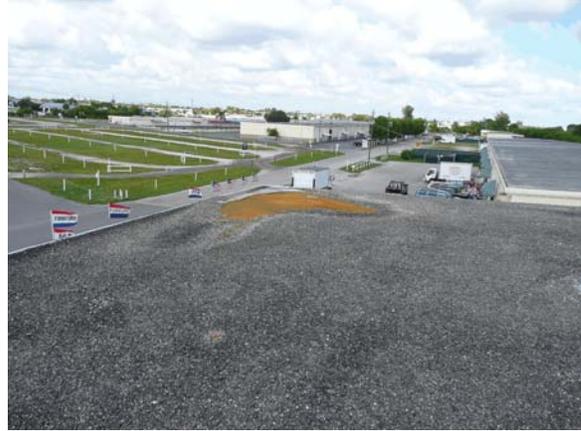
**Figure 7:** Typical scour pattern (Roof No. 4).

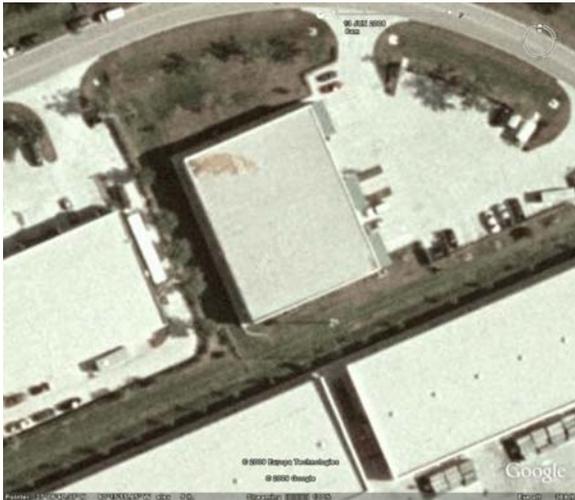
**Figure 8:** Typical scour pattern (Roof No. 2).  
Photo courtesy Google Earth.

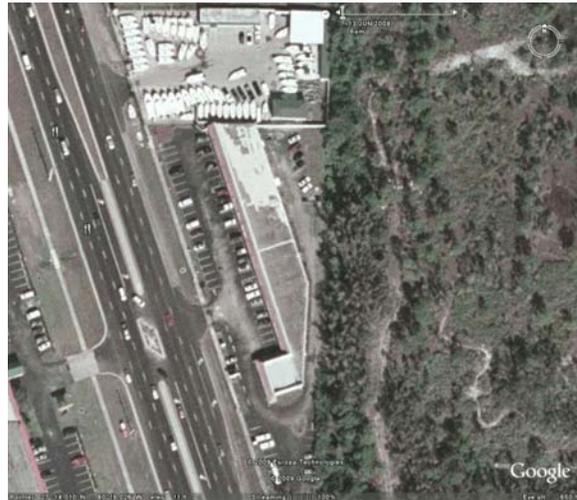
Only one roof in the study was observed or reported to have had a loss of aggregate. This particular building (Roof No. 13) had the smallest aggregate diameter of the study (0.245 inches) and was classified as Exposure C. The roof has a high parapet on the west exposure (66 inches) but the eastern side (exposure was an open field) had no parapet. The aggregate loss apparently caused no damage as it was never determined where it landed (likely in the adjoining field). The X-value for this roof was the most negative of the study at -52.

**Figure 9:** Roof No. 13 exhibited aggregate loss. Roof had no parapet on the side facing Exposure C. Aggregate loss was from the northern half of this roof. Photo courtesy Google Earth.

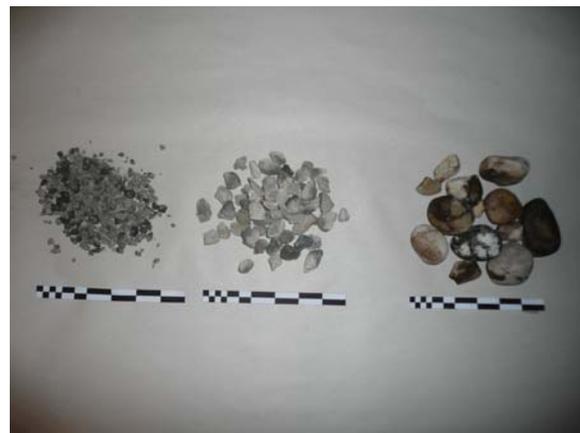
Average diameter varied from 0.245 to 1.50 inches. The largest size was aggregate recycled from a ballasted single-ply roof. The smallest sizes (7, 78 and 8) were locally described as “pea gravel.” Fines were found to be minimal and well within ASTM D 448 specification.

**Figure 10:** Aggregate varied in average diameter between <math>\frac{1}{2}</math> inch and 1½ inch. Most roofs had Size 67 (nominally ½” diameter).
